SHEEPY PARISH COUNCIL

Sheepy Parish Council Sibson Flooding Issue CCTV Survey

December 2022 (updated 01 August 2023)*

Report prepared by: Jason Stephenson (Clerk) and Rob Ward (Chair, SPC)

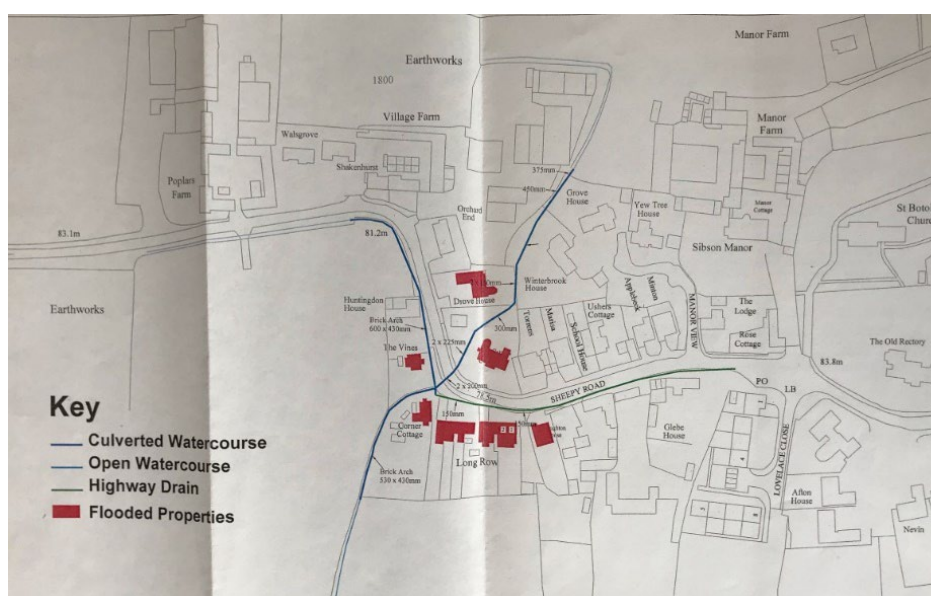
The Parish Council like many of its parishioners is concerned about flooding within the Parish. One of the areas of concern over recent years is the flooding that occurs on Sheepy Road Sibson; this has affected a number of properties within this area during times of heavy rainfall (diagram 1).

Diagram 1. Properties that have experienced flooding on Sheepy Road, Sibson (HBBC report, 2002).

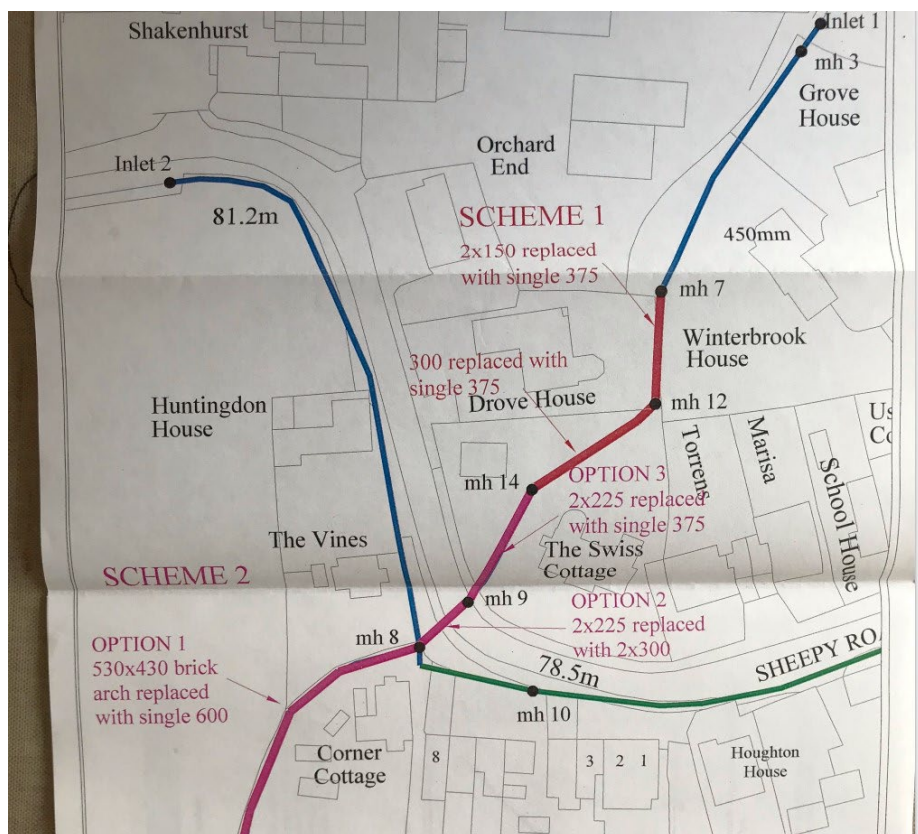
The reports recommended that the system be thoroughly cleansed, and that the highway drainage should be improved. It was also recommended that changes/improvements be made to the drainage pipework and highway drainage. These were presented as a number of options and schemes (diagram 4): Scheme 1 aimed to provide protection for up to a 1 in 20-year flood event and Scheme 1 plus Scheme 2 (with all options implemented) to provide protection against a 1 in 100-year flood event.

Diagram 4. Recommended Options contained in HBBC report (2002).

The Borough Council implemented Scheme 1 only and this led to 20m of the twin 150mm diameter pipe passing through Willowbrook House and Drove House properties being replaced, 25m of the 300mm pipe within Swiss Cottage property being replaced by 375mm pipe plus associated manhole construction/improvement carried out.

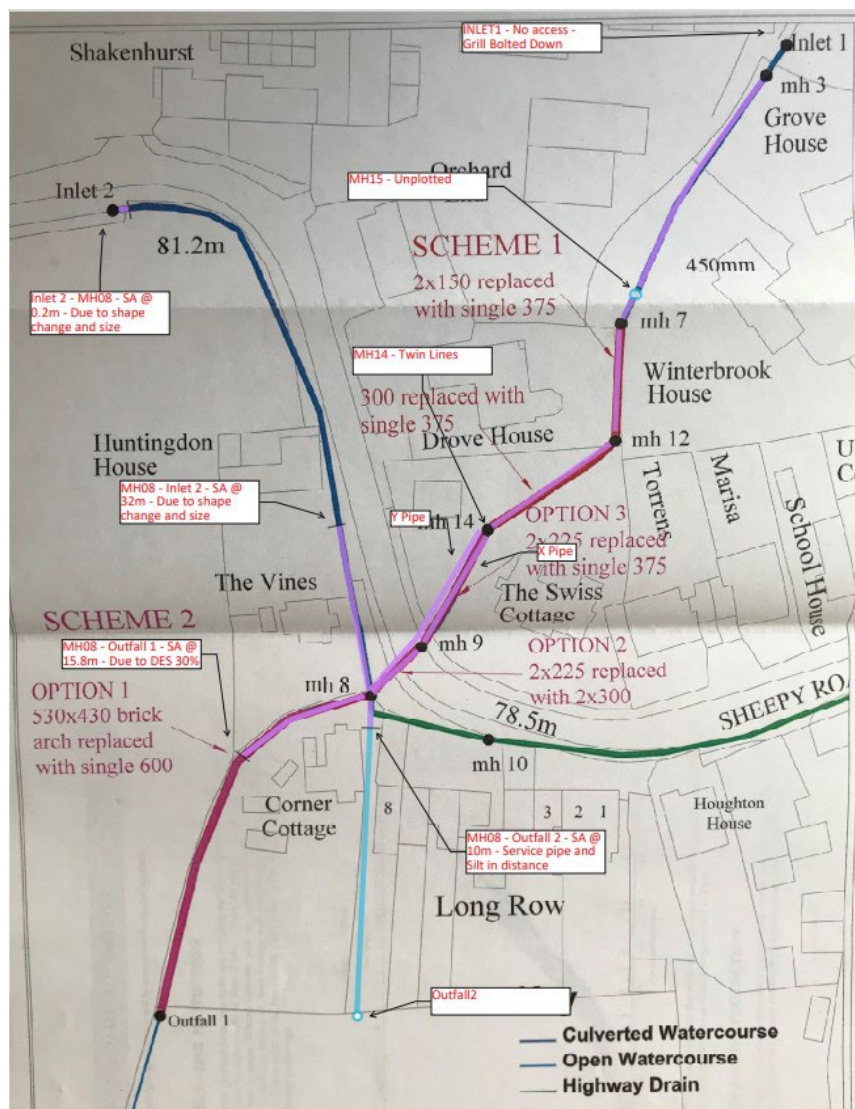
The findings of the CCTV survey are summarised in Diagram 6 and Table 1.

Diagram 6. CCTV Survey results (2022). Key: MH – inspection chamber, SA – survey aborted.

Pipe Length	Section	Diameter	Findings
MH14x to MH9	1	225mm	No Issues
MH8 to Outfall 1	2	490mm	Displaced and missing bricks, Fine roots and survey was abandoned at 15.8m due to 30% debris in pipe
MH8 to Outfall 2	3	460mmx430mm	5% debris, intruding connection, Survey was abandoned at 1m due to a Service Pipe obstruction
MH8 to Inlet 2	4	600mm x 580mm	5% debris displaced brick, intruding connection, Fine roots. Survey abandoned at 32m due to change in shape of sewer

Pipe Length	Section	Diameter	Findings
Inlet 2 to MH8	5	300mm	Survey abandoned at 0.2m due to change in material
MH14 to MH12	6	375mm	No Issues
MH12 to MH7	7	375mm	No Issues.
MH7 to MH15	8	375mm	No Issues
MH15 to MH3	9	375mm	Broken Pipe and mass roots
MH14x to MH9	10	225mm	No Issues
MH14y to MH9	11	225mm	No Issues
MH9x to main	12	225mm	Broken pipe, connects to main without manhole at 11.4m
Mh9y to main	13	225mm	Settled deposits, connection to main with manhole at 11.4m

MH8 to Outfall 1 – Pipe is to be cleansed and a root cut undertaken, the remaining (unsurveyed) section of the pipe is then surveyed to ascertain its condition and further remedial work undertaken if necessary; a full reline of the pipe maybe required.

MH8 to Outfall 2 – A service pipe is visibly obstructing the surface water drainage pipe; this is to be removed and diverted with the remaining (unsurveyed) section of the pipe then surveyed to ascertain its condition and further remedial work undertaken if necessary.

Inlet 2 to MH8 - A service pipe is visibly obstructing the surface water drainage pipe, this is to be removed and diverted with the remaining (unsurveyed) section of the pipe then surveyed to ascertain its condition and further remedial work undertaken if necessary. Patch lining will be required where bricks are missing.

MH15 to MH 3 – Full cleansing of pipe and root cutting needs carrying out, patch lining where the pipe is also broken

MH9x,y to MH8 – Full cleansing of the pipework and patch lining where pipe is broken.
