SHEEPY PARISH COUNCIL

Sheepy Parish Council Sibson Flooding Issue CCTV Survey

December 2022 (updated 01 August 2023)*

Report prepared by: Jason Stephenson (Clerk) and Rob Ward (Chair, SPC)

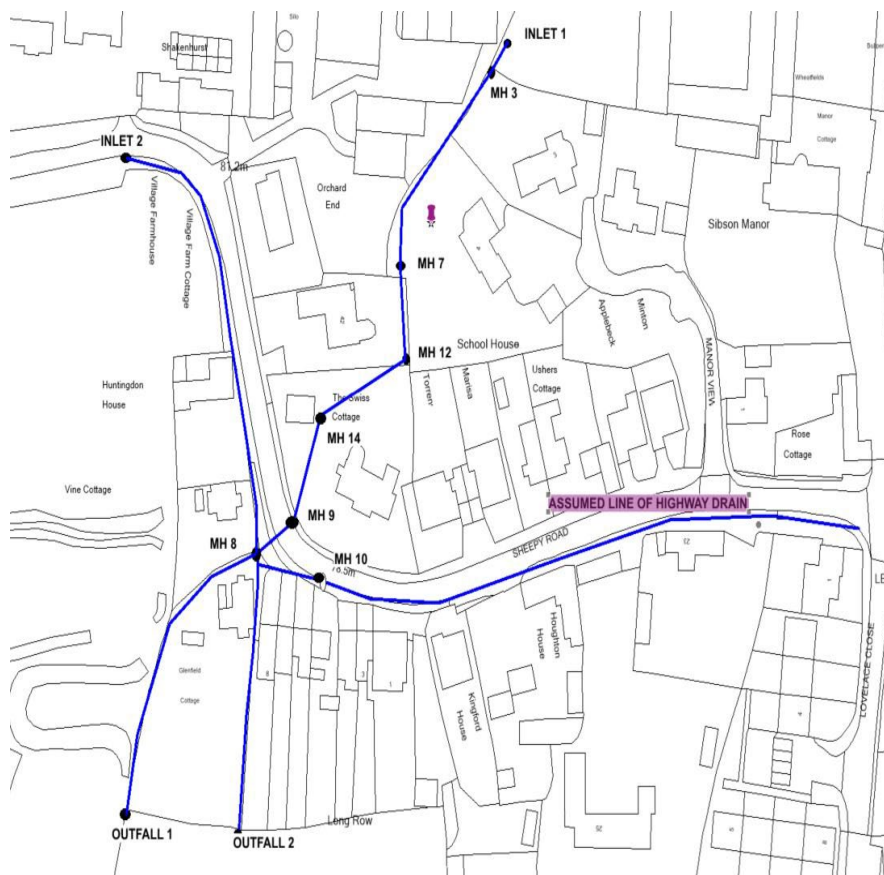
Diagram 5. Extent of the survey work (HBBC report, 2002).

The survey has also confirmed all of the pipe sizes, which indicates that the Scheme 1 recommended work was carried out with the pipe size from MH14 to MH3 now 375mm diameter. None of the Scheme 2 works appear to have been carried out.
